# Manhole Inspection Summary

Manhole # S53K\_\_015MH

Insp Date: **7/29/08 2:43 PM**

**Location** Address: **3230 fleet foster** Cross Street: **bouldin clinton**

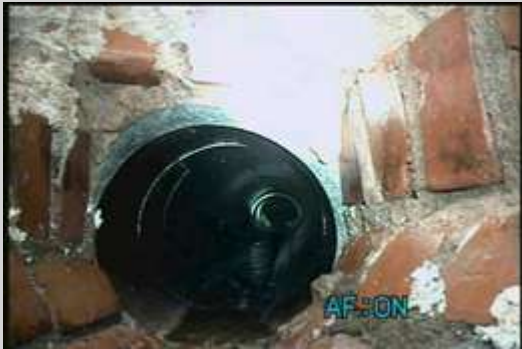
12 O'Clock Outflow

Pipe Material: **Clay** ☐ Pipe Lined

Invert Depth: **9.41** (ft.) Flow Characteristics: **Slow**

Infiltration: **None** Pipe Seal Cond: **Unknown**

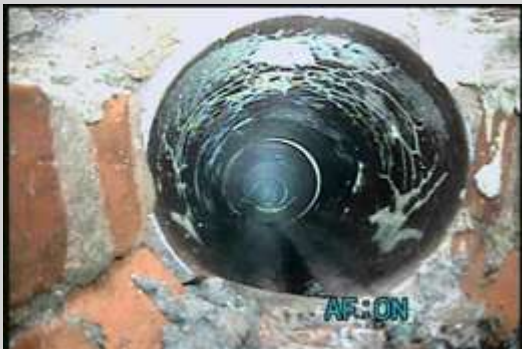
3 O'Clock Inflow

Pipe Material: **Clay** ☐ Pipe Lined

Invert Depth: **9.10** (ft.) Flow Characteristics: **Slow**

Infiltration: **None** Pipe Seal Cond: **Unknown**

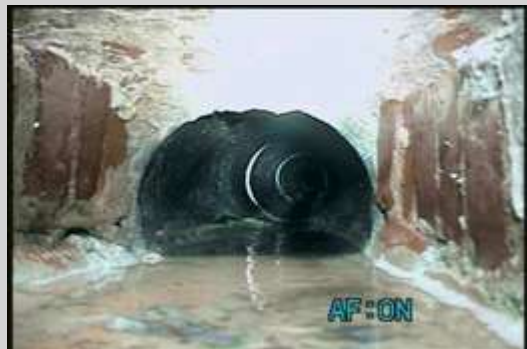
6 O'Clock Inflow

Pipe Material: **Clay** ☐ Pipe Lined

Infiltration: **None** Pipe Seal Cond: **Unknown**
